Using Secondary Voltage Data to Detect Struggling Distribution Transformers

C. Bolig, T. Laughner, R. Price, M. Wilkin
Whisker Labs
USA

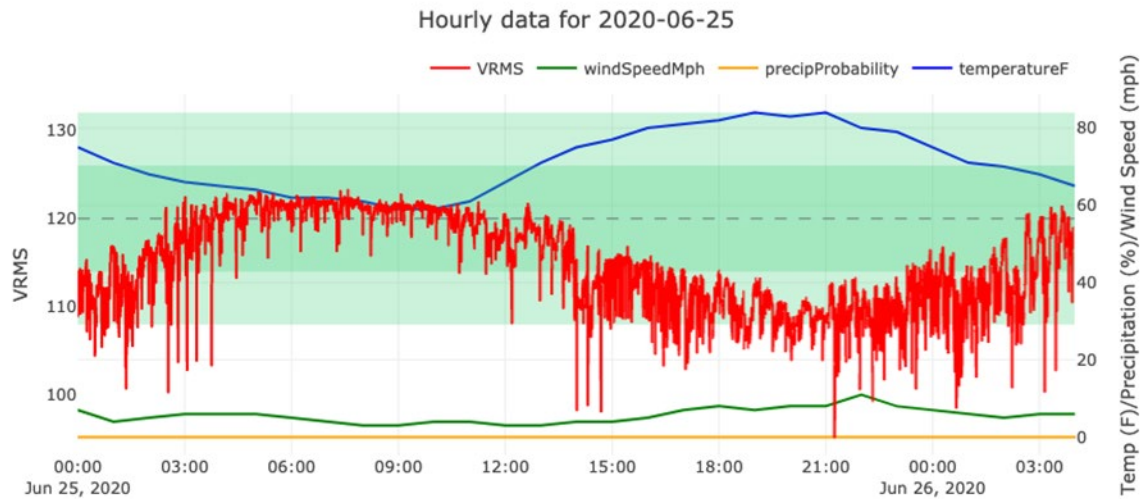
Figure 1: Plot of root-mean-square (rms) Voltage vs. Time. The red line indicates the voltage, the green line indicates wind speed, the yellow line indicates the chance of precipitation, and the blue line indicates temperature. The voltage values are on the left axis, the weather values are on the right axis. The meandering, "sinusoid" voltage pattern can be seen - along with its peak during the coldest time of day - and its trough during the hottest time of day.

During Power Quality reviews in the summer of 2020, a significant number of sensors reported unusual and meandering voltage patterns, similar to a sinusoid. A more rigorous review of this sinusoidal behavior indicated a correlation between air temperature in the region and the amplitude of the sinusoidal voltage pattern (see Figure 1).

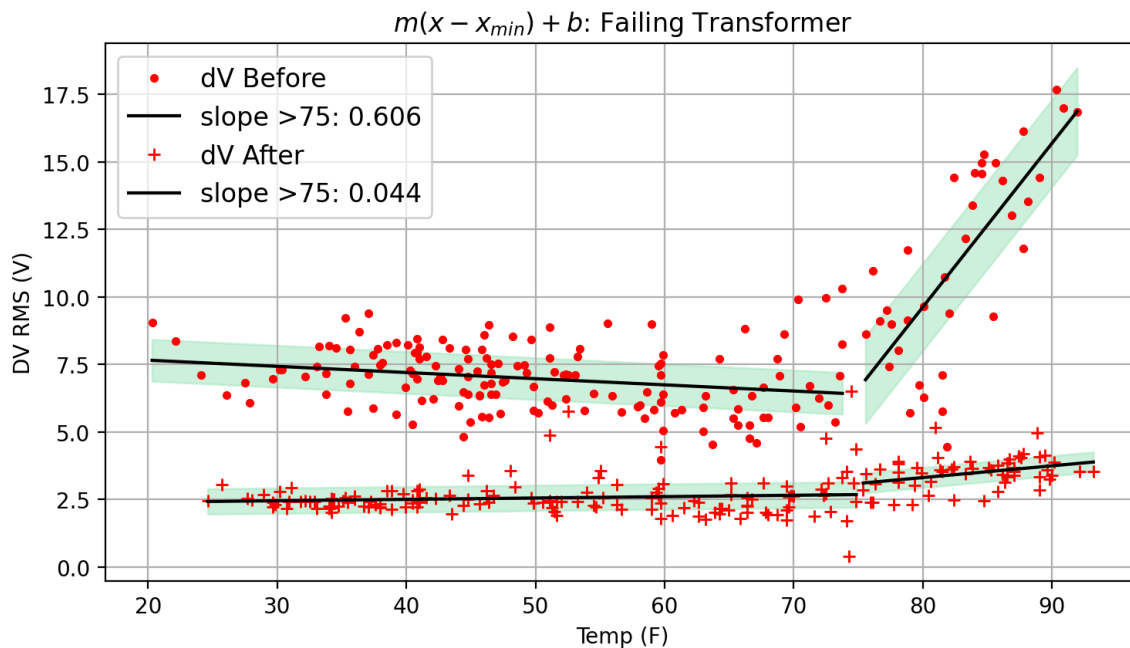
Figure 2: This scatter plot illustrates the difference in the changing voltage before and after replacing the distribution transformer serving the home. The daily change in V_{rms} is plotted on the y-axis, with the daily high temperature on the x-axis. The circular points illustrate the change in voltage for a given daily high temperature before transformer replacement, while the "+" points indicate the same data after replacement. This plot shows a correlation between the maximum daytime temperature and the voltage change for an overloaded transformer.

An invaluable discovery arose in June 2020, when one case allowed us to look at a home's voltage both before and after a distribution transformer was replaced. Before replacement, sensor data exhibited the sinusoidal pattern. After replacement, the sinusoidal voltage pattern ceased (see Figure 2).

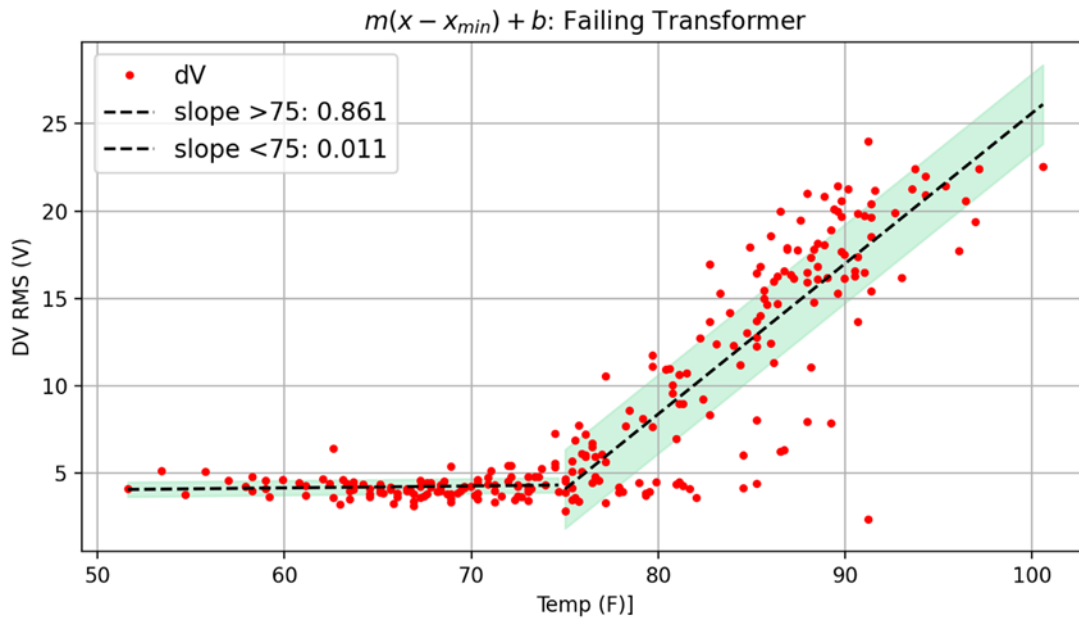
Figure 3: Scatter plot showing the relationship between the daily change in voltage and the maximum temperature during the day. The daily change in voltage is plotted on the y-axis, while the temperature is represented on the x-axis. The plot illustrates that once reaching a certain daily high temperature, the voltage begins to vary significantly over the course of the day. Furthermore, this variation becomes more extreme as the maximum temperature increases.

Where everyday data over a period (typically several weeks) has an adequate temperature variation - and is plotted as a scatter plot of change in the voltage (ΔV) versus maximum air temperature for the day - positive slope for homes that exhibit sinusoidal voltage behavior is observed. Furthermore, when a least-squares fit is applied, the positive slope can be quantified (See Figure 3).

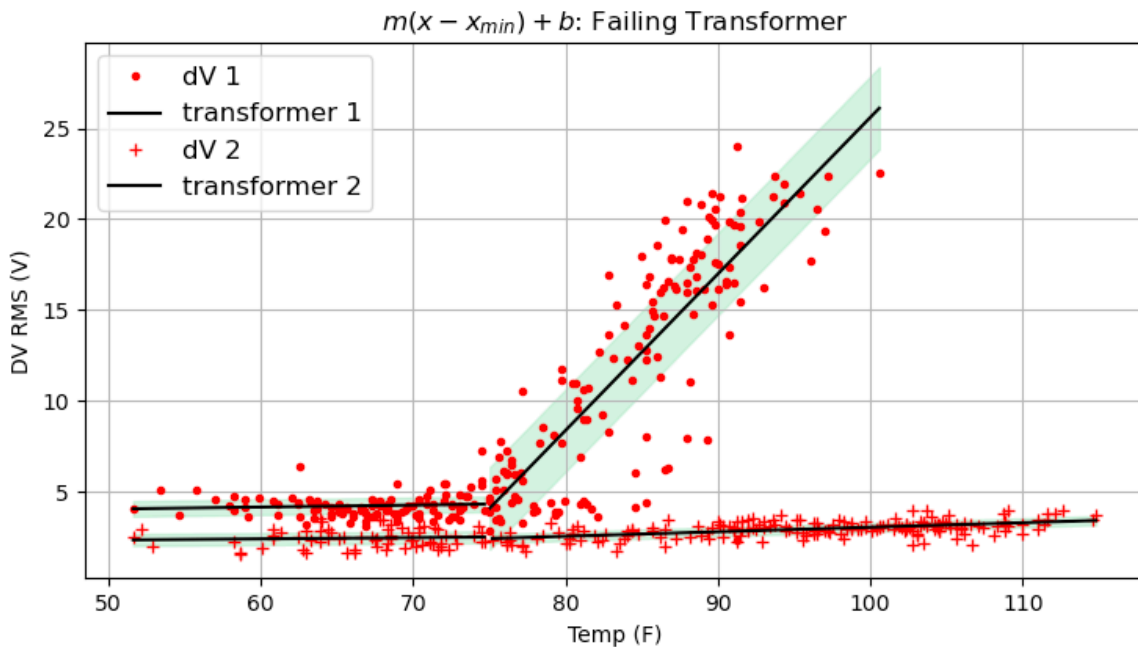
Figure 4: A scatter plot of change in voltage vs. maximum daytime temperature. This plot illustrates the difference between a transformer believed to be struggling (transformer 1) and a normal operating transformer (transformer 2).

When comparing this data to similar data from a transformer known to be new and operating under similar conditions, the difference is immediately identifiable (See Figure 4).

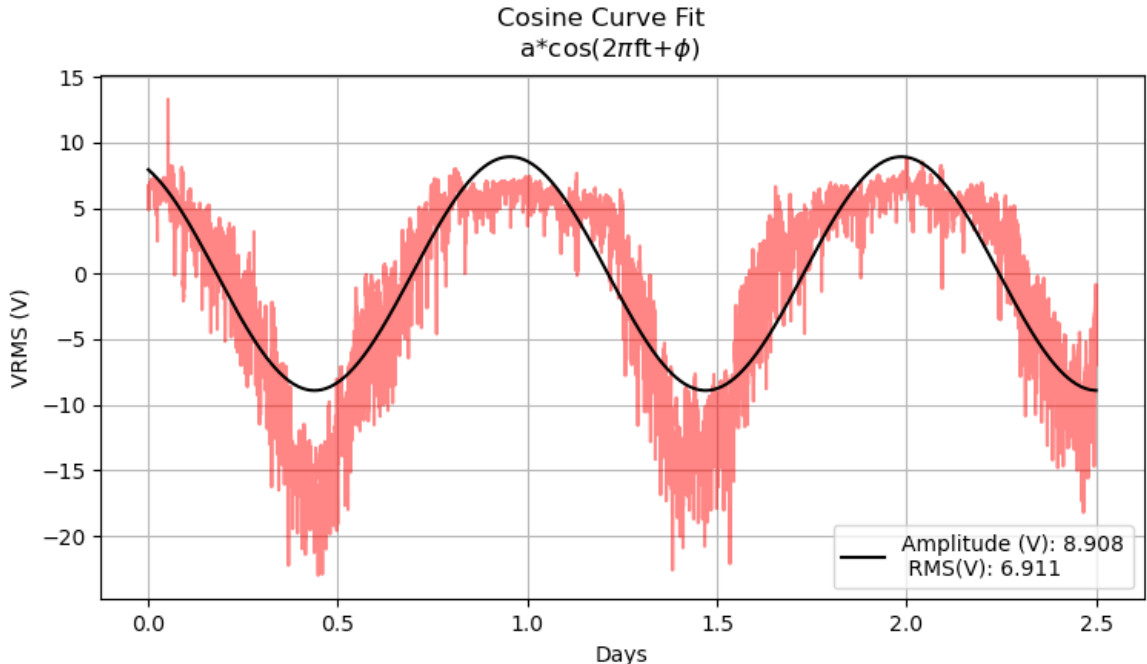
Figure 5: Two and a half days of voltage data, centered around zero, and its best-fit cosine curve. The plot shows the sinusoidal nature of a transformer dependent on the outside temperature. At $t=0$ the voltage data started at approximately 5 am for the homeowner's local time, therefore having the highest likelihood for cool temperatures and least load. In turn, this corresponds with a max voltage at $t = 0$, or a cosine curve with little phase shift.

Subsequently, the use of Fourier Transforms (FT) and a cosine best fit identify potential faulty/overloaded transformer sites using data from just two and a half consecutive hot days. In this case, the FT algorithm of best fit processes the characteristic sinusoidal pattern, and

frequency and amplitude are defined (see Figure 5). The units are such that the frequency component of one equates to 1 cycle/day.

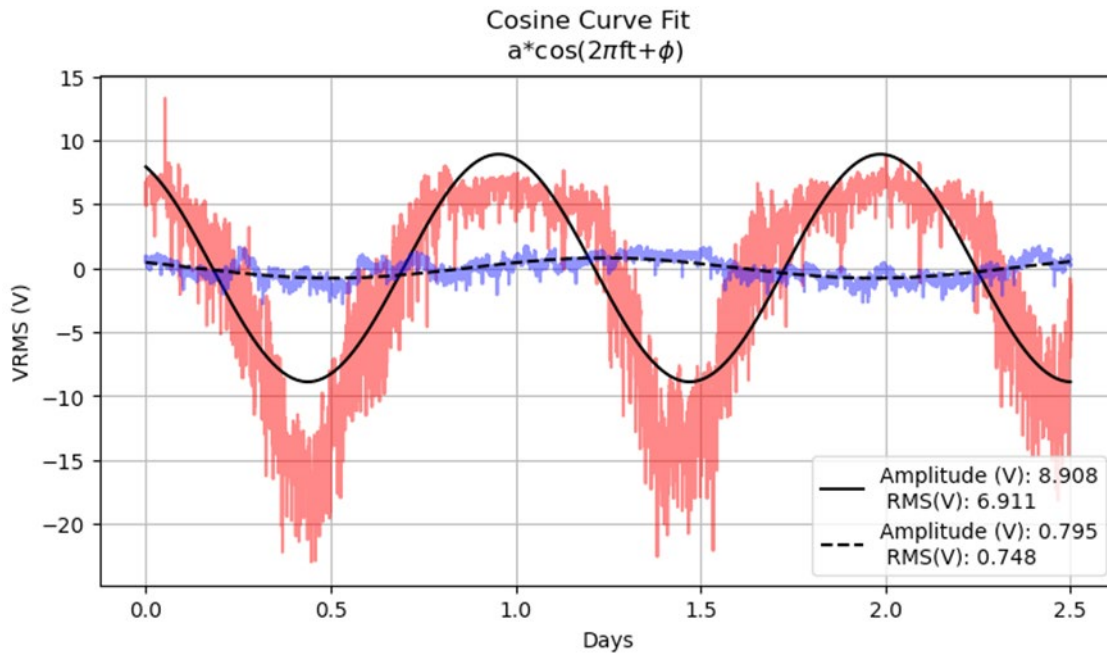
Figure 6: Voltage data from Figure 6 compared to a normal operating transformer's voltage, plotted in blue. The voltage in blue is from the same sensor as the linear comparison presented in Figure 5. Both voltages are taken from the hottest two and one-half consecutive days in August, with temperatures above or near 100 degrees. A well-behaved transformer may still show some daily sinusoidal patterns. However, when comparing the blue (normal) voltage to the red voltage of the failing transformer, the blue cosine fit possesses an amplitude value that is smaller than an order of magnitude than the red voltage's amplitude.

The difference is readily observable when a suspected struggling transformer is plotted alongside a normal transformer (see Figure 6).

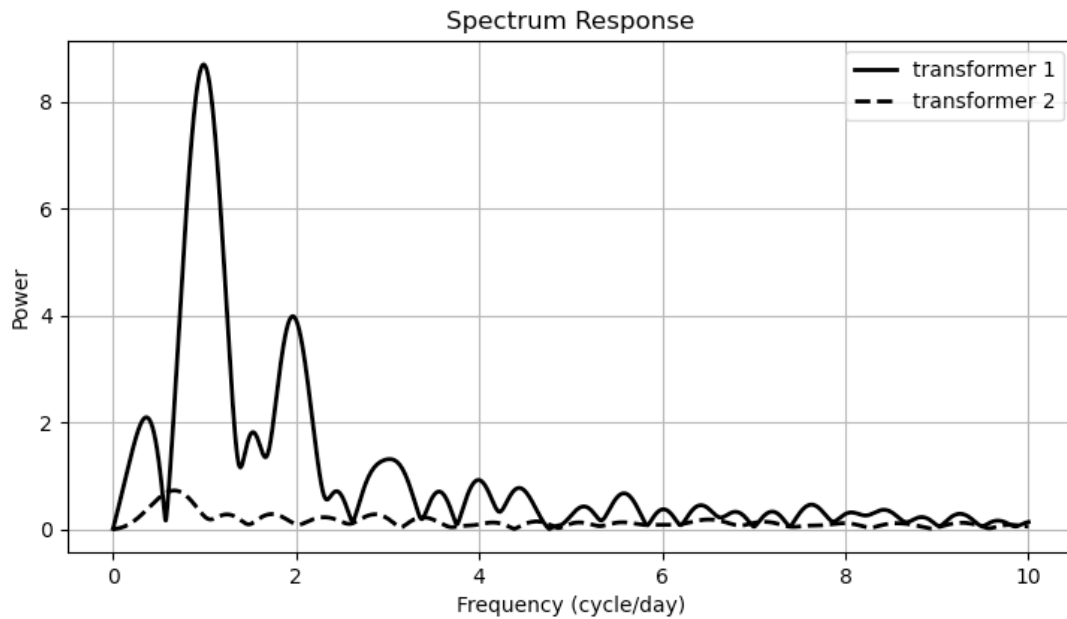
Figure 7: This plot illustrates the results of the Fourier analysis. The graph for the struggling transformer has a strong response around 1 Hz, indicating that a struggling transformer will produce a voltage graph that cycles like a sine wave over the course of a day. The same response is not present for a transformer that is operating properly. This approach is consistent with the methods of identifying struggling transformers.

In Figure 7, a Fourier analysis was conducted on two transformers (one suspected of struggling, and the other thought to be good) from 0 frequency to 10 cycles per day. This plot reveals a significant response around 1 Hz (cycle/day), as the voltage output inversely follows the outside temperature and has a large one cycle/day component in the data. The control transformer's voltage output dependency is so low on the daily load that the expected noise in the voltage data greatly outweighs any frequency component.
